Intel[®] Mobile Celeron[™] Processor at 466 MHz, 433 MHz, 400 MHz, 366 MHz, 333 MHz, 300 MHz, and 266 MHz Specification Update

Release Date July 2000

Order Number: 244444-016

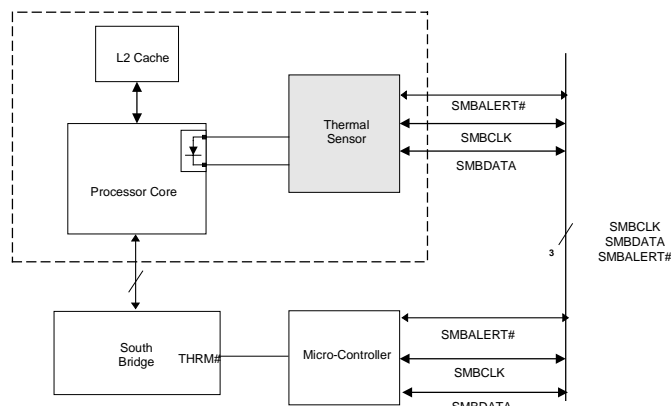
Figure 1. An Example of Microcontroller Driven Thermal Management

H29. Thermal Sensor May Assert SMBALERT# Incorrectly

Problem: The Intel Celeron Processor Mobile Module has a thermal sensor that monitors the processor core's temperature. Please note that desktop systems could have a similar thermal device. The thermal sensor asserts SMBALERT# if the processor temperature exceeds the temperature limits set in the Alarm Threshold Registers (T_{HIGH} , T_{LOW}). It also sets the corresponding Status Register bits to identify the cause of the interrupt. Figure 1 gives one example of the how the SMBALERT# signal could be used in a system.

Implication: There is no system impact from this erratum if temperature polling is used for processor thermal management. If the SMBALERT# interrupt is employed to manage processor thermal sensing, then servicing the false interrupt may result in premature system action depending on the software and hardware implementations used. The rate of the false interrupts is less than the auto-convert rate of the thermal sensor.

Workaround: Three different (mutually exclusive) workarounds are possible:

1. Before servicing an interrupt from the thermal sensor, read and compare the processor thermal reading with the threshold limits (T_{HIGH} or T_{LOW}). Figures 2 and 3 provide basic flowcharts for the implementation of this workaround in an interrupt driven system.
2. If the firmware implemented polls the Status Register only, then before taking any action, re-read the temperature register and do a comparison with the alarm threshold limits (T_{HIGH} or T_{LOW}) to determine if the value is actually still within the temperature window.
3. Use a temperature polling scheme to monitor the processor temperature.

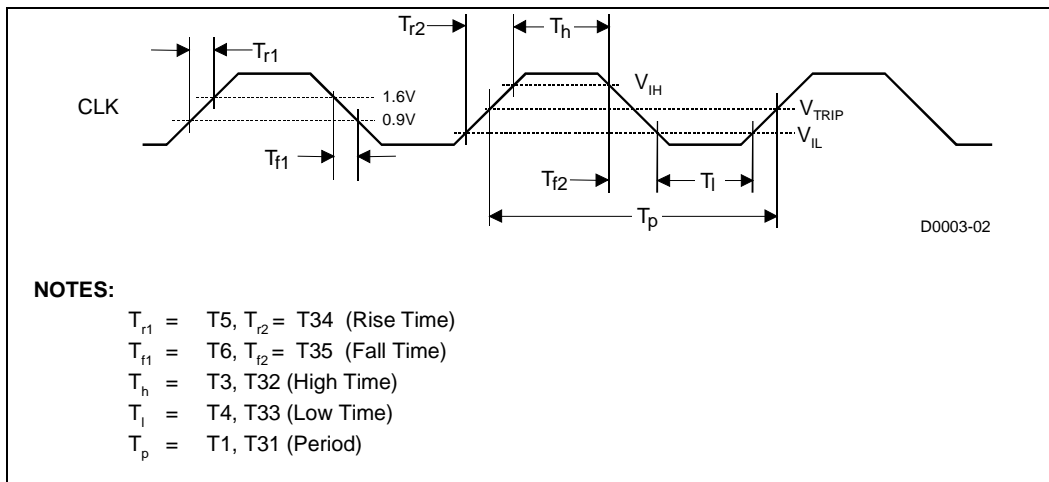
Figure 3.3 Generic Clock Waveform

H11. Generic Clock Waveform Figure

Figure 3.3 in the *Intel® Mobile Celeron™ Processor in μPGA1 and BGA1 Packages at 366 MHz, 333 MHz, 300 MHz, and 266 MHz* datasheet (Order Number 245112-003) has been updated. The following figure is to replace the one in the above document.
